EVALUATION OF A VISUAL ASSISTANCE SYSTEM TO SUPPORT MANUAL SCARF REPAIRS FOR A DIGITALIZED AIRCRAFT MAINTENANCE

Abstract

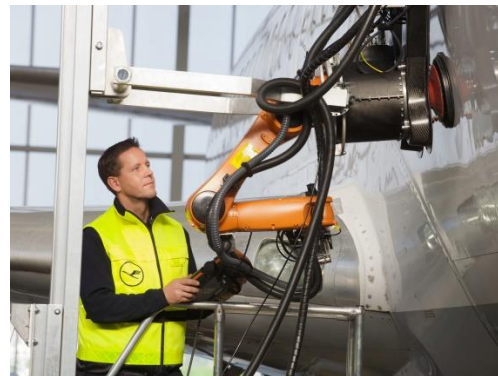
The system in FIG. 3 is build up within the *LuFo* projekt "CAIRe" (FKZ 20W1101A) and consists of a portable robot arm which is mounted directly on the damaged structure via suction cups and is equipped with a milling unit. A laser scanning system allows to scan the surface and based on this data the software calculates the travel path for the implemented milling unit which creates the scarf geometry automatically. [5]

FIG. 3 Automated scarfing with CAIRE System [12]

Fully automated systems such as *CAIRe* are particularly suitable for the repair of major damage to large fuselage or wing segments which either cannot be disassembled or at least not without increased workload. The system from the *Supcrafted* project is also specially designed for on-wing repairs, but initially for slightly curved structures.

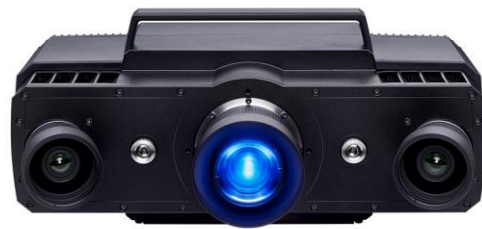
FIG. 5 GOM Atos 5 system [9]

The *ATOS 5* [9] system, see FIG. 5, from *GOM* provides the best results, not at least because of its encapsulated housing [9] whereby the system has a significant advantage which allows its usage under real industrial conditions. Thus the system is safe from CFRP dust which occurs during grinding. The dust can be electrically conductive and can lead to short circuits of exposed electrical components. [10] After the surface is scanned by the structured light projector, the software interface allows to program various application for calculating geometric bodies or contours. So the scanned surface and the calculated bodies/contours can be combined or compared within a deviation analysis for example. It's also possible to reproject these geometric contours and visualizes them on the component surface, see the example in FIG. 15 in chapter 7.1. It is one of the important functions to realize visual support during the scarfing process.

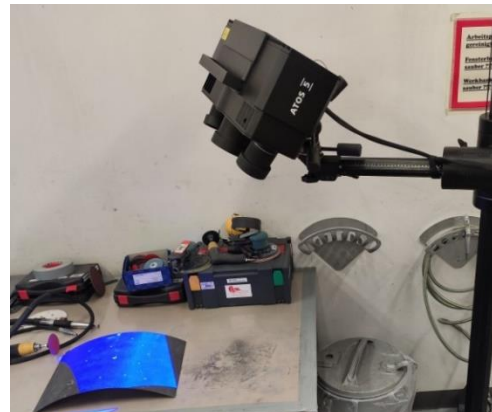
FIG. 12 shows the test setup for assisted scarfing with the *GOM ATOS 5*. The tests were carried out in a separate workshop area of Lufthansa Technik (Hamburg) with the room lighting switched on in order to evaluate the visibility of the projections on the surface under realistic conditions.

FIG. 12 Test setup for assisted scarfing process at Lufthansa Technik (Hamburg) on single curved CFRP samples [12]

The measuring system requires an additional computer with a corresponding software package, which is connected to the scanner via a control unit. After the damage location has been defined on the CFRP sample, it has to be prepared with optical markers which are glued on around the damaged area.
